Internal Technical Reference
071 8437 00 August 26, 2005
Reference ECO: 032M

Trinix™ IP-33500 512 x 512 Interface Board Upgrade

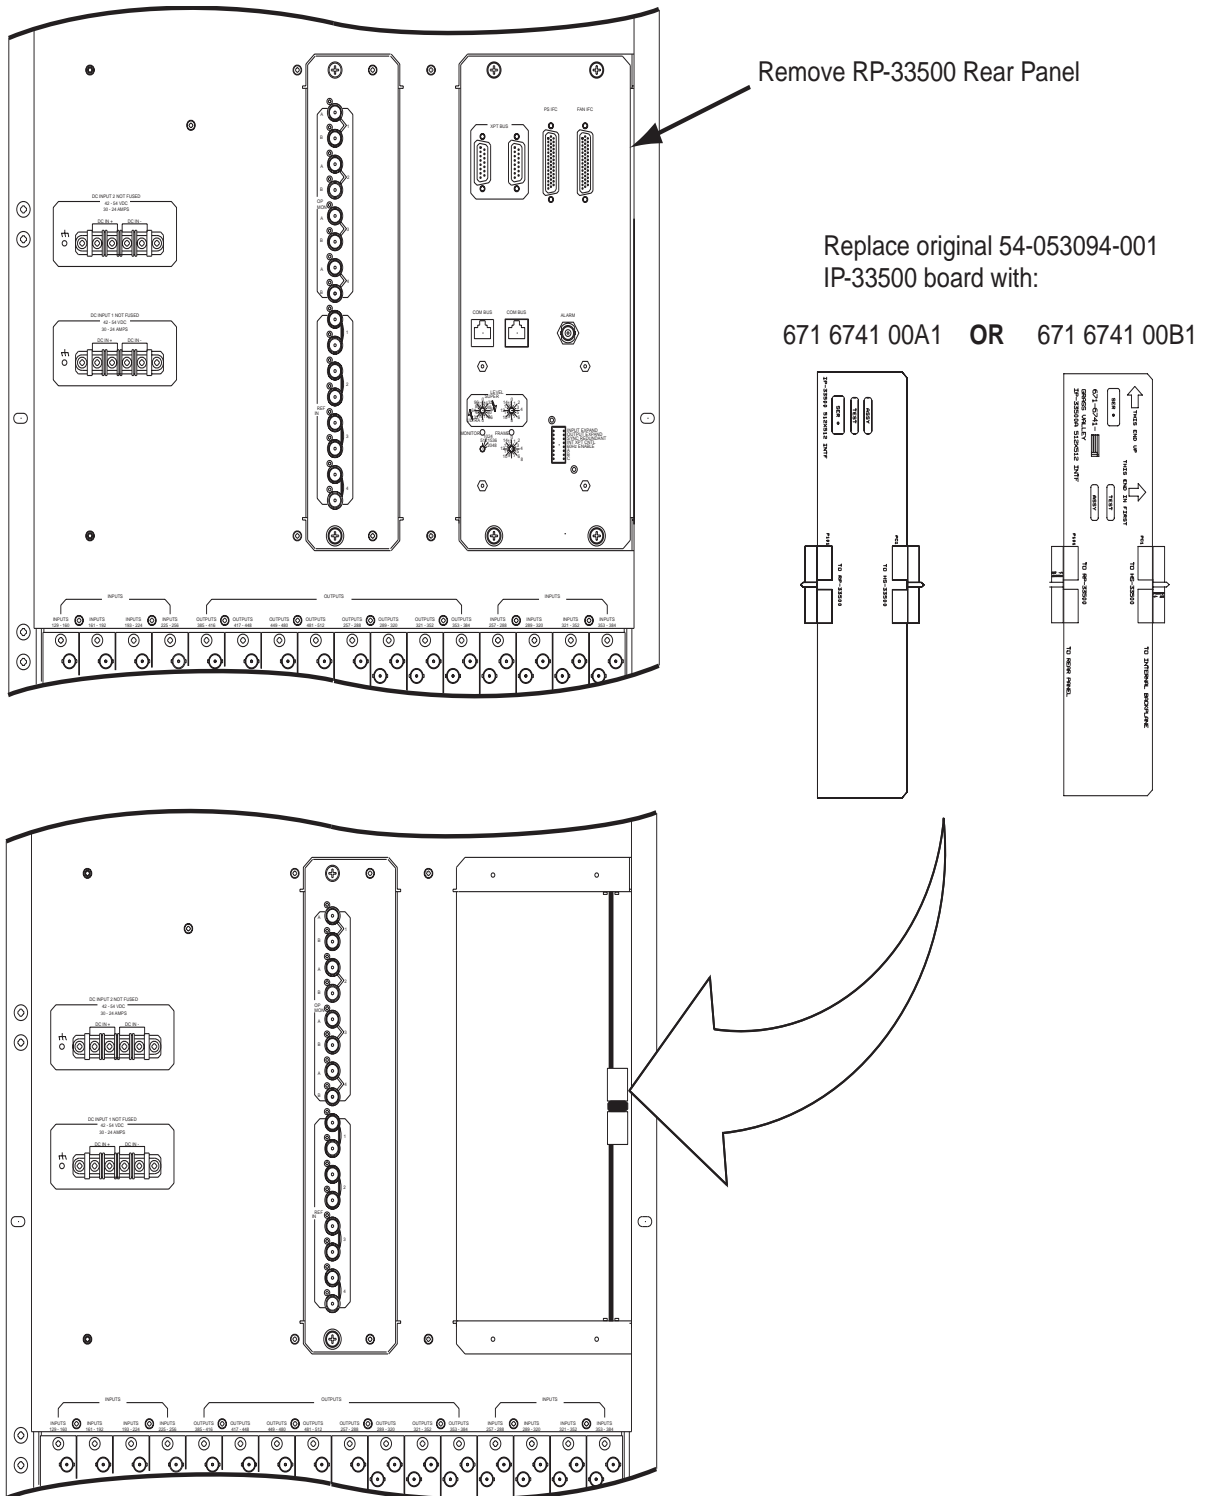
Figure 1. Installation of new IP-33500 board

A wiring error was discovered in the Trinix 512 x 512 router system that prevented one supply voltage from reaching the RP-33500 rear panel. Other redundant supply voltages allowed the RP-33500 to operate normally. The additional loading on the other supplies reduced their voltage. This caused occasional low voltage alarms in some of the other Trinix boards that monitor or use those 4.7 volt redundant supplies. The modified IP-33500 board restores the missing supply connection to the RP-33500 boards.

2. Remove all cables connected to the RP-33500 Rear Panel.
See Figure 1 for the location of the RP-33500.
3. Remove the RP-33500 panel.
There are four screws securing this panel.
4. Pull out the socket-mounted IP-33500 512 x 512 Interface board, part no. 54-053094-001, from the HS-33500 backplane.

5. Carefully install the supplied IP-33500 board, part no. 671 6741 00A1 or 671 6741 00B1.

Note the silk screen labels which indicate the interior ("To HS-33500") and exterior ("To RP-33500") connectors. Also, the part number / serial number silk screening will be on the top end of the IP board when properly positioned.
