XIP-3901-DC

Release History

UPGRADE PACKAGE: 2.1.0

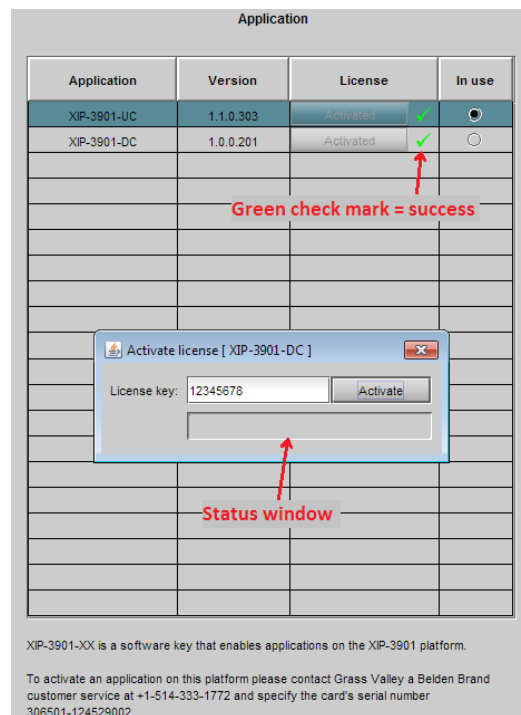
[XIP3901DC-833](#)

Application Manager does not show success after activating a license.

To activate an application, click the Activate button in the License column. In the Activate license dialog box that appears, enter the license key and click Activate. If the key is valid, the status window under the key should become green to indicate success but does not. Yet successful activation of the license is confirmed with the green check mark that now appears in the License column. The dialog box can now be closed. See the following image:

Green check mark = success

Status window
