Field Engineering Bulletin
071 8283 04 Sept. 28, 2005
Reference ECO: 110M

Broadlinx 2.2.2 Upgrade

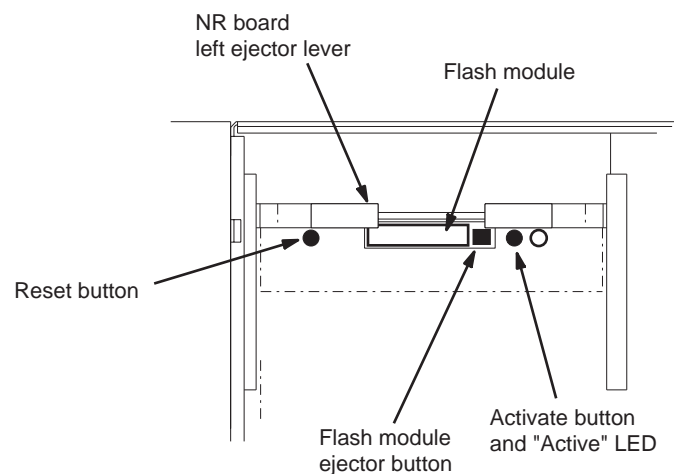
Figure 2. NR-33000 reset/activation controls.

1. Install the provided compact flash memory module(s) in the NR-33000 memory slot(s) as follows:
 - a. If there are two NR-33000 boards, locate the inactive board. See Figure 1 and Figure 2.

Jupiter- and **Encore-**controlled systems - press the “Activate” button (see Figure 2). The “Active” LED indication will switch to this board. Note that a Secondary (amber) alarm will be asserted when the Secondary NR is active.

SMS 7000-controlled system - press the “Reset” button on the **active** NR-33000 (see Figure 2). The “Active” LED indication will switch to the opposite board.

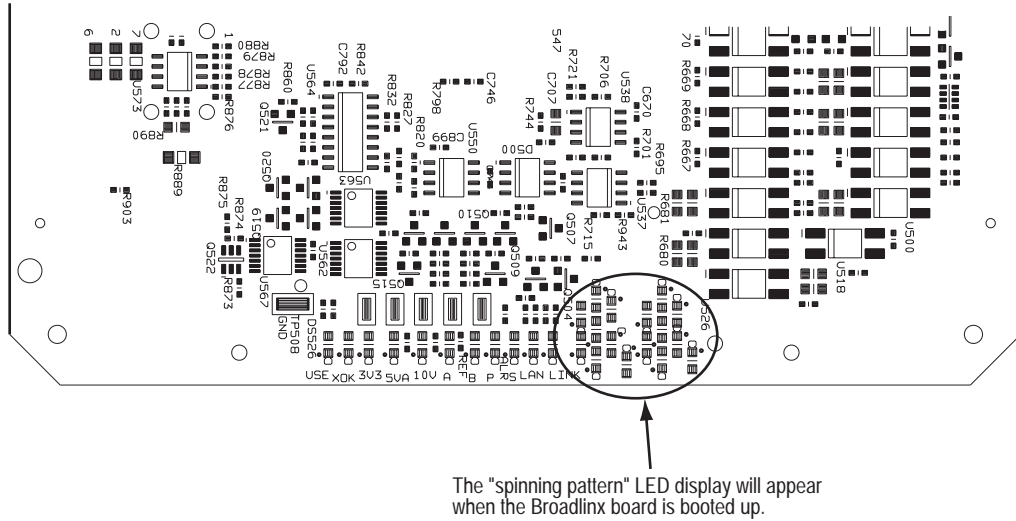
The boot process will take about 45 seconds, after which you will see a “spinning” pattern of the LEDs on the front edge of the board. See Figure 3.

Figure 3. Broadlinx board LEDs.

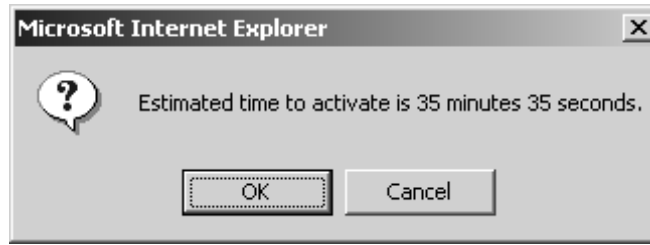
Figure 5.

2. Select "Activate." An "Estimated Time" display will appear:
