Field Engineering Bulletin
071828309 January 19, 2007

Trinix Broadlinx 2.4.1 Upgrade

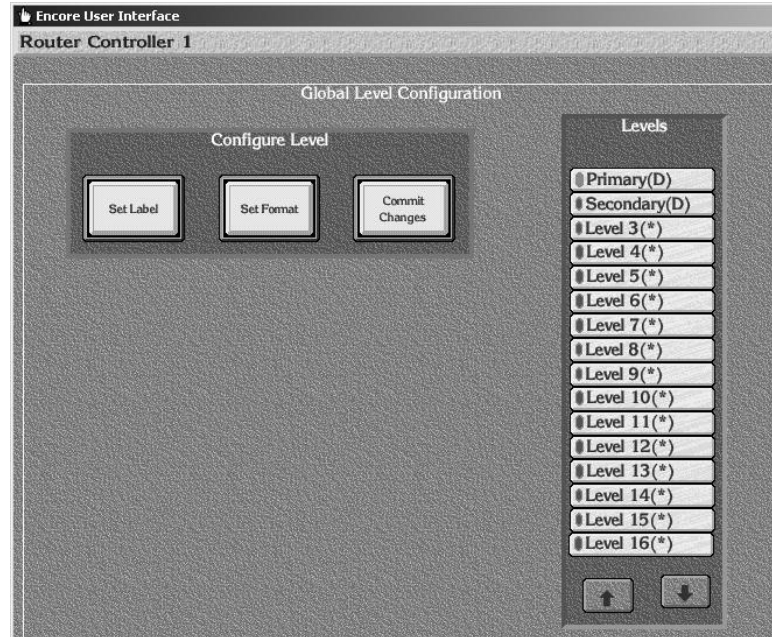
Figure 5.

1. Create two levels (one for each of the primary and secondary paths):
