grass valley NV8500 v3.7.0 Upgrade and Downgrade Procedures

TN0107-00 • Technical Note

The Upgrade Procedure for Routers at Firmware Version 2.2.0 and Later

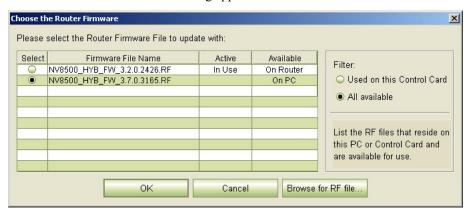
The 'Choose Router Firmware' dialog appears:

Because you are installing new firmware, click 'Browse for RF File'.

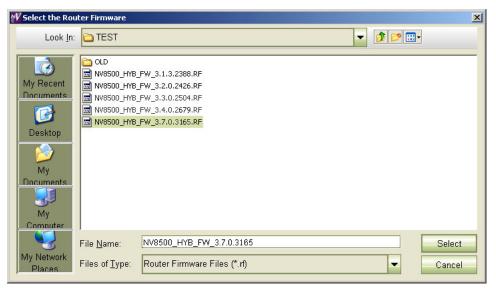
The 'Select Router Firmware' dialog appears:

Here, navigate to a folder that contains the firmware file you want. At this revision, the file is NV8500_HYB_FW_3.7.0.3165.RF. Highlight the file and click 'Select'.

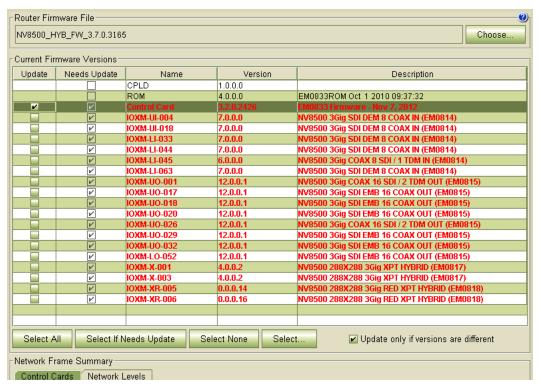
The 'Firmware' page changes to highlight all cards in need of updating (in red):

5 Click 'Select None' to deselect all cards. Then select the control card by marking its check box in the 'Update' column.

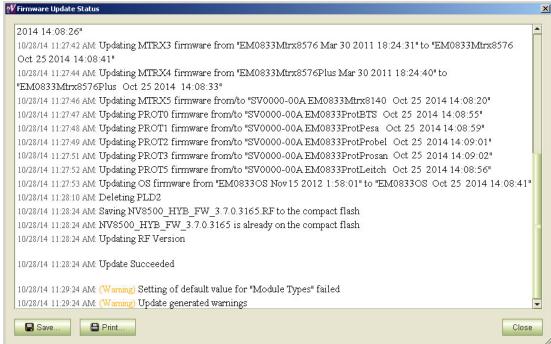
Frame1	Frame2	
\checkmark	\checkmark	6 Click 'Update Firmware' (at the bottom of the page).
		⊚ Update Firmware
		The update takes about 5 minutes. Click 'Yes' in response to any confirmation or warning message.
\checkmark	\checkmark	7 When the update has finished, MRC displays a log of the updates. It should normally say "All updates were successful" at the end.

If the update was not successful, try the update again, once or twice. If the update continues to fail, try resetting the control card and try the update again. If the update fails after that, contact Grass Valley customer service.

Because you have updated the firmware, but have not yet updated the IOXM cards, you might see a message such as "Setting of default values for module types failed" as shown in the illustration above.

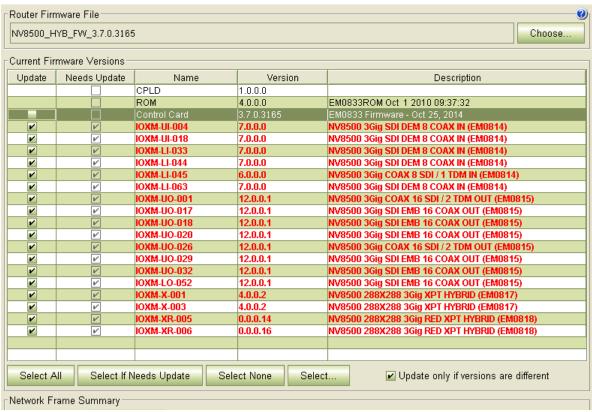
The 'Update Firmware' page highlights all cards in need of updating (in red):

3 Click the 'Selected if Needs Update' button.

4 Make sure that the control card is unselected.

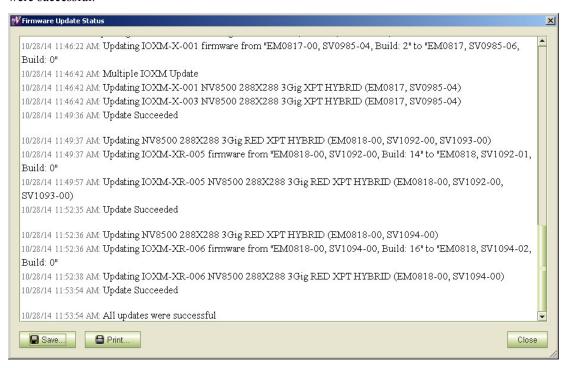
6 When the update is complete, MRC displays a log of the updates. It should normally say "All updates were successful."

Examine the update log. If it reports any failure, retry the update for the failed card.

▲ If the update for an individual card fails, respond 'Skip' to the Retry message that appears. Perform all retry attempts after the update finishes and produces its report.

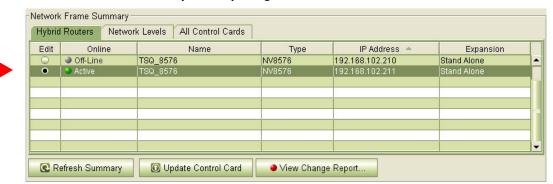
2 Choose **Card A** of the router you are updating:

If you are updating an expanded NV8576-Plus, you must select **Card A** of the master frame. MRC will present a dialog asking you to identify the slave frame. Choose the slave frame in this dialog. (But do *not* select the slave frame in the 'Control Cards' tab at the bottom of the 'Module Types' page!)

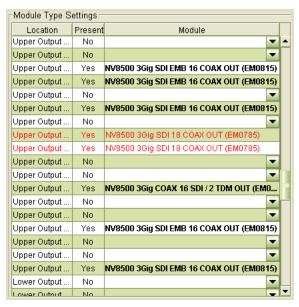
3 It is possible that, after you perform step 6 (Firmware Updates for IOXM Cards) the 'Module Types' page reports errors—with red text—for some or all of your modules:

This is not an immediate cause for alarm. It can occur because of differences in configuration requirements between your old system and the new firmware and software.

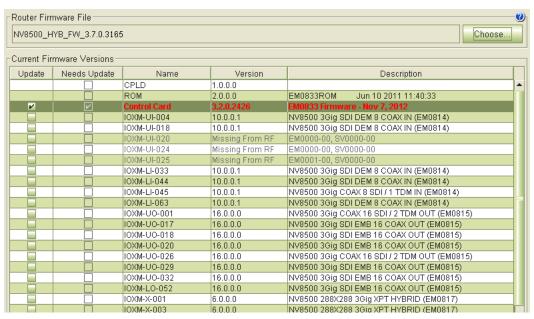
The 'Firmware' page changes to highlight the control card (in red):

Ignore any messages such as "Missing from RF" in the illustration above.

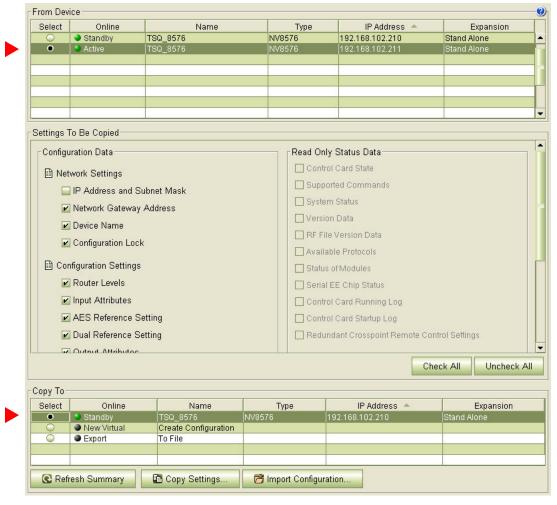
- 1 Go to the 'Copy Settings' page of MRC.
 - 2 Select **Card A** in the 'From Device' table at the top of the page. The 'To Device' table, at the bottom of the page, will redisplay according to your selection. Select **Card B** in the 'To Device' table.

- 3 Leave the entries in the 'Settings to Be Copied' section, in the middle of the page, at their defaults.
- 4 Click the 'Copy Settings' button.

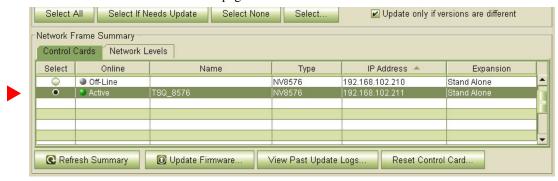
- 1 Completely remove **Card B** (the standby control card, assuming there is one). Close the router door.
 - 2 Go to the 'Firmware' page in MRC. Click 'Refresh Summary'.
 - 3 Select **Card A** at the bottom of that page.

The stand-by card (Card B) should read 'Off-Line'.

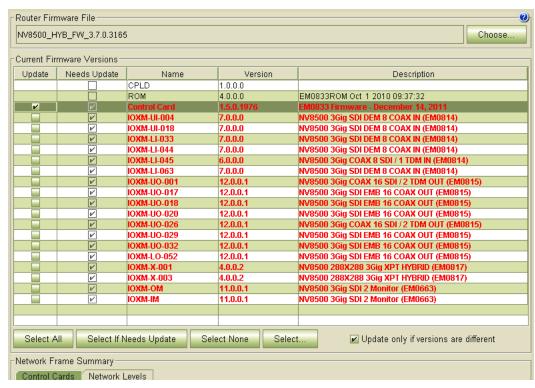
The 'Firmware' page changes to highlight all cards in need of updating (in red):

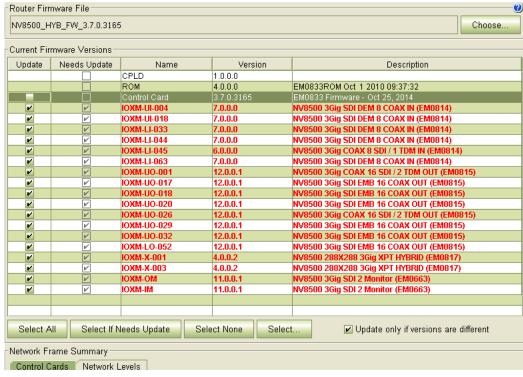
The 'Update Firmware' page highlights all cards in need of updating (in red):

3 Click the 'Selected if Needs Update' button.

4 Make sure that the control card is unselected. You are updating only IOXM cards in this step.

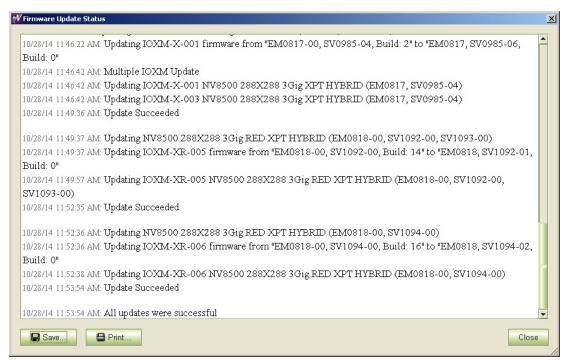
6 When the update is complete, MRC displays a log of the updates. It should normally say "All updates were successful."

Examine the update log. If it reports any failure, retry the update for the failed card.

▲ If the update for an individual card fails, respond 'Skip' to the Retry message that appears. Perform all retry attempts after the update finishes and produces its report.

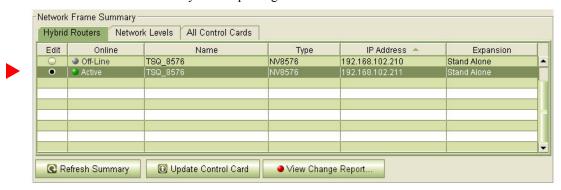
2 Choose **Card A** of the router you are updating:

If you are updating an expanded NV8576-Plus, you must select **Card A** of the master frame. MRC will present a dialog asking you to identify the slave frame. Choose the slave frame in this dialog. (But do *not* select the slave frame in the 'Control Cards' tab at the bottom of the 'Module Types' page!)

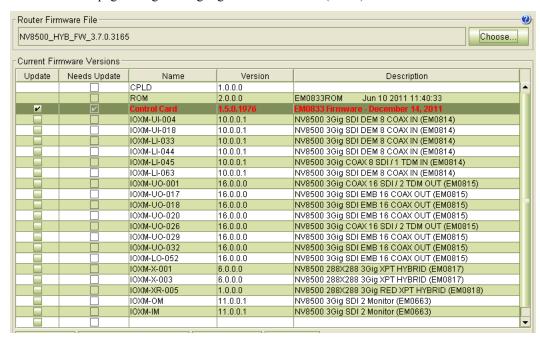
The 'Firmware' page changes to highlight the control card (in red):

Ignore any messages such as "Missing from RF" in the illustration above.

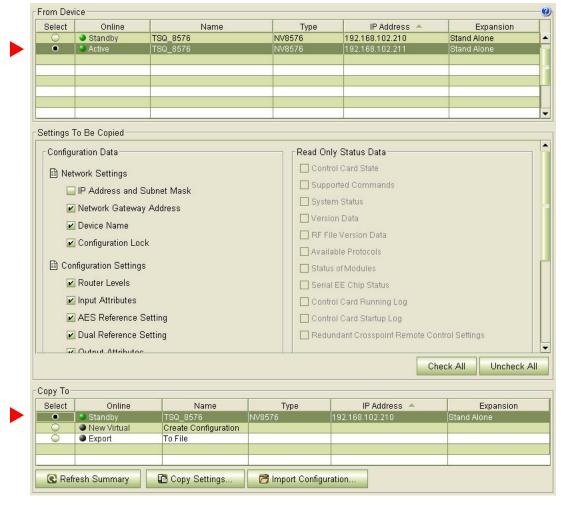
- 1 Go to the 'Copy Settings' page of MRC.
 - 2 Select **Card A** in the 'From Device' table at the top of the page. The 'To Device' table, at the bottom of the page, will redisplay according to your selection. Select **Card B** in the 'To Device' table.

- 3 Leave the entries in the 'Settings to Be Copied' section, in the middle of the page, at their defaults.
- 4 Click the 'Copy Settings' button.

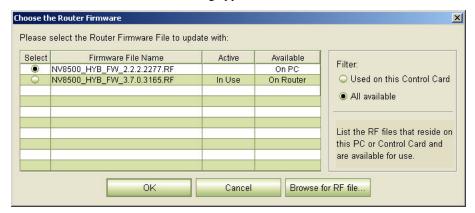
The 'Choose Router Firmware' dialog appears:

Because you are reverting to older firmware, choose 'All Available' at the right side of the dialog and click 'Browse for RF File'.

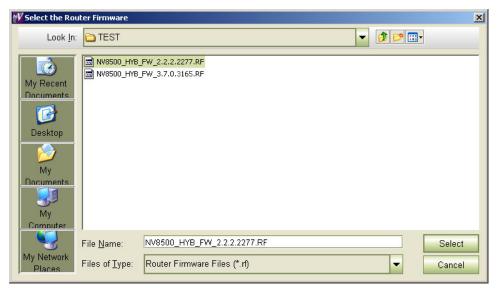
The 'Select Router Firmware' dialog appears:

Here, navigate to a folder that contains the firmware file you want. The firmware file is named something like NV85ØØ_HYB_FW_2.2.2.2277.RF. Highlight the file and click 'Select'.

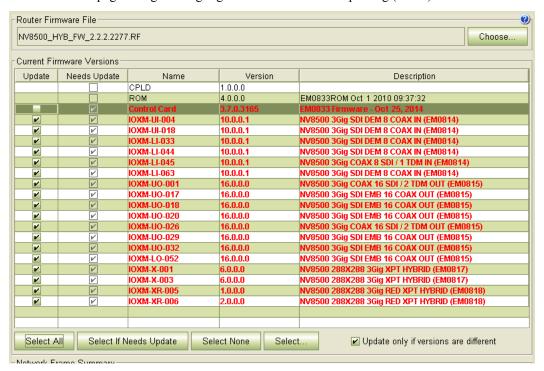
The 'Firmware' page changes to highlight all cards in need of updating (in red):

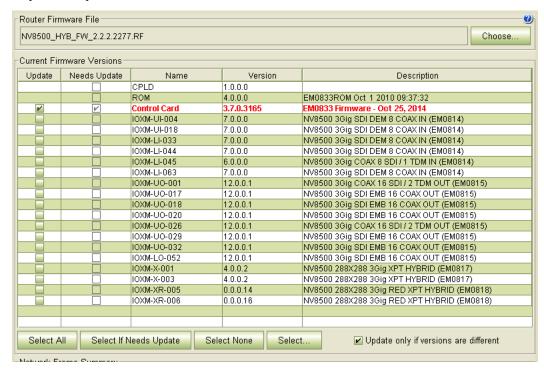
The 'Update Firmware' page changes to highlight all cards in need of updating (in red). At this step, the only card to update is the control card:

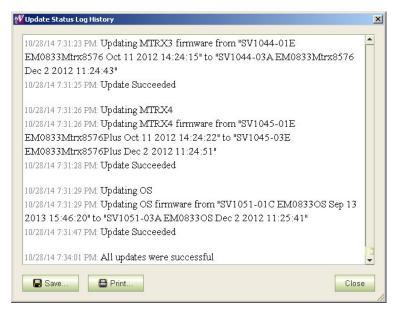
6 When the update has finished, MRC displays a log of the updates. It should normally say "All updates were successful" at the end.

If the update was not successful, try the update again, once or twice. If the update continues to fail, try resetting the control card and try the update again. If the update fails after that, contact Grass Valley customer service.

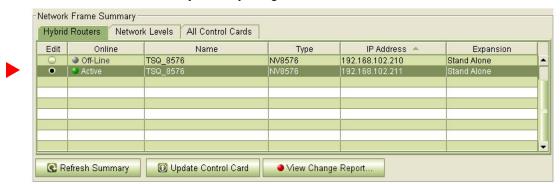
- 7 Redefine the I/O Card Types (for Card A)
- 1 Go to the 'Module Types' page of MRC.
 - 2 Choose **Card A** of the router you are updating:

If you are updating an expanded NV8576-Plus, you must select **Card A** of the master frame. MRC will present a dialog asking you to identify the slave frame. Choose the slave frame in this dialog. (But do *not* select the slave frame in the 'Control Cards' tab at the bottom of the 'Module Types' page!)

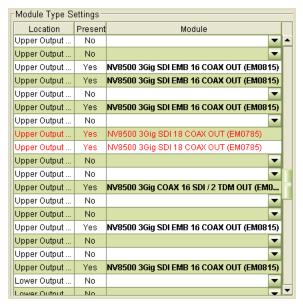
3 It is possible that, after you perform step 6 (Firmware Updates for IOXM Cards) the 'Module Types' page reports errors—with red text—for some or all of your modules:

This is not an immediate cause for alarm. It can occur because of differences in configuration requirements between your old system and the new firmware and software.

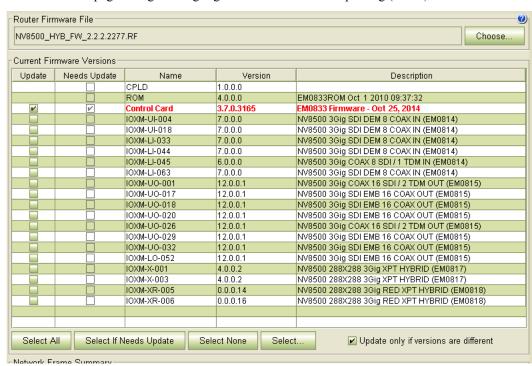
4 The 'Firmware' page should report the same firmware file you used to revert the IOXM cards and **Card**A. If it does not, locate and select the firmware file as you did for **Card** A. The firmware file name is named something like NV85ØØ_HYB_FW_2.2.2.2277.RF.

The 'Firmware' page changes to highlight all cards in need of updating (in red):

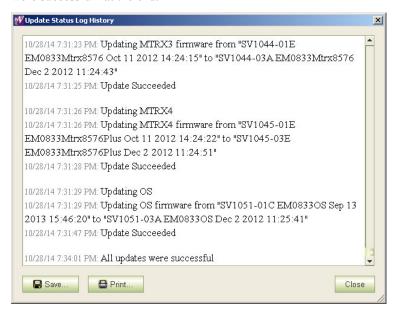
8 When the update has finished, MRC displays a log of the updates. It should normally say "All updates were successful" at the end.

If the update was not successful, try the update again, once or twice. If the update continues to fail, try resetting the control card and try the update again. If the update fails after that, contact Grass Valley customer service.

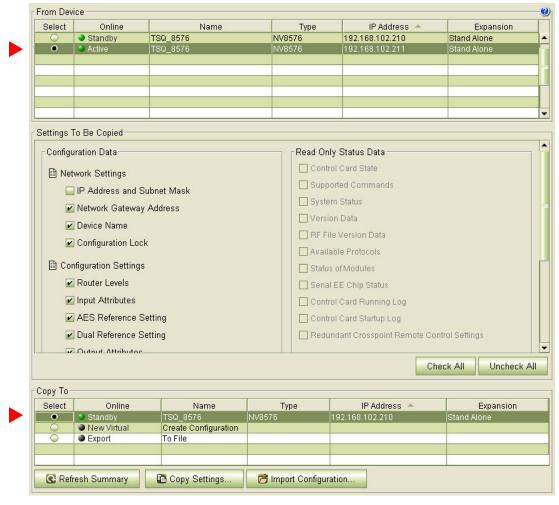
- 1 Go to the 'Copy Settings' page of MRC.
 - 2 Select **Card A** in the 'From Device' table at the top of the page. The 'To Device' table, at the bottom of the page, will redisplay according to your selection. Select **Card B** in the 'To Device' table.

- 3 Leave the entries in the 'Settings to Be Copied' section, in the middle of the page, at their defaults.
- 4 Click the 'Copy Settings' button.

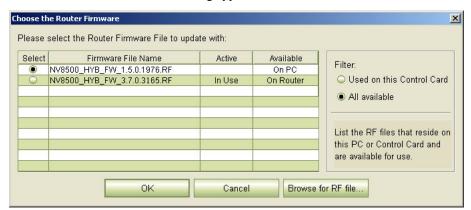
The 'Choose Router Firmware' dialog appears:

Because you are reverting to older firmware, choose 'All Available' at the right side of the dialog and click 'Browse for RF File'.

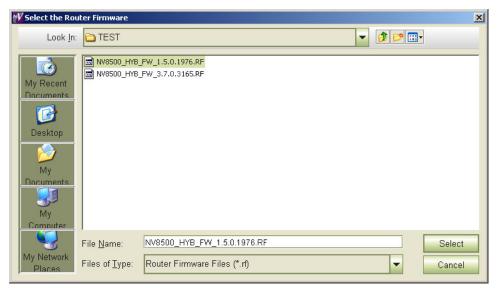
The 'Select Router Firmware' dialog appears:

Here, navigate to a folder that contains the firmware file you want. The firmware file is named something like NV8500_HYB_FW_1.5.0.1976.RF. Highlight the file and click 'Select'.

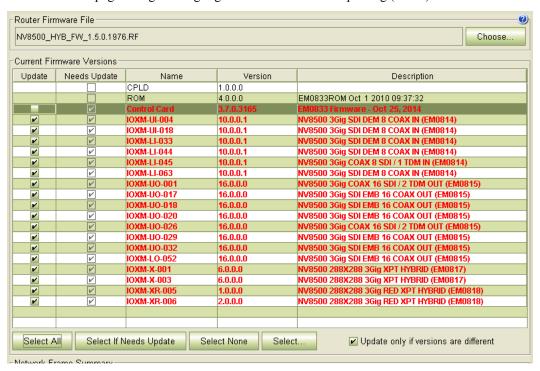
The 'Firmware' page changes to highlight *all* cards in need of updating (in red):

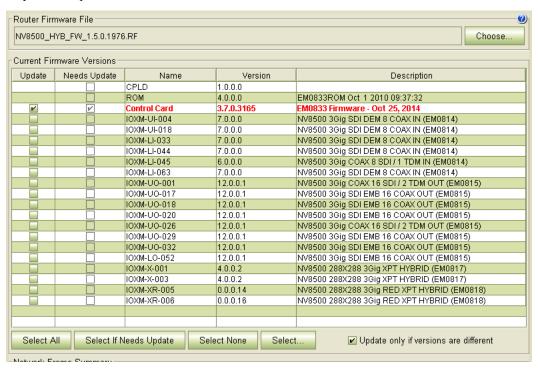
The 'Update Firmware' page changes to highlight all cards in need of updating (in red). At this step, the only card to update is the control card:

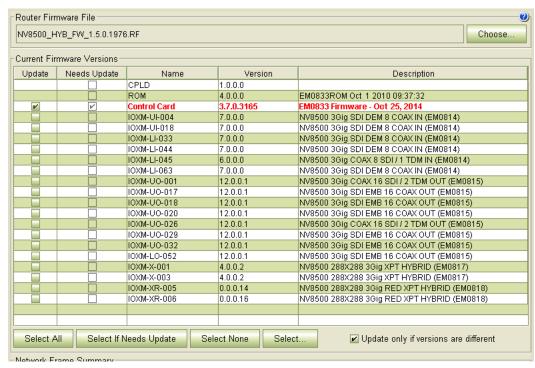
5 The 'Firmware' page should report the same firmware file you used to revert the IOXM cards and **Card**A. If it does not, locate and select the firmware file as you did for **Card** A. The firmware file name is named something like NV8500_HYB_FW_1.5.0.1976.RF.

The 'Firmware' page changes to highlight all cards in need of updating (in red):

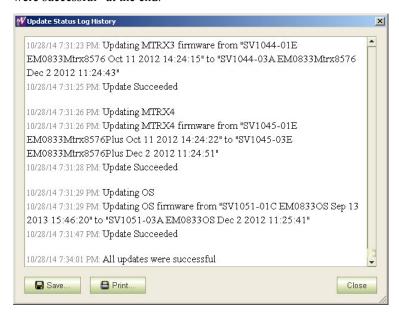
9 When the update has finished, MRC displays a log of the updates. It should normally say "All updates were successful" at the end.

If the update was not successful, try the update again, once or twice. If the update continues to fail, try resetting the control card and try the update again. If the update fails after that, contact Grass Valley customer service.

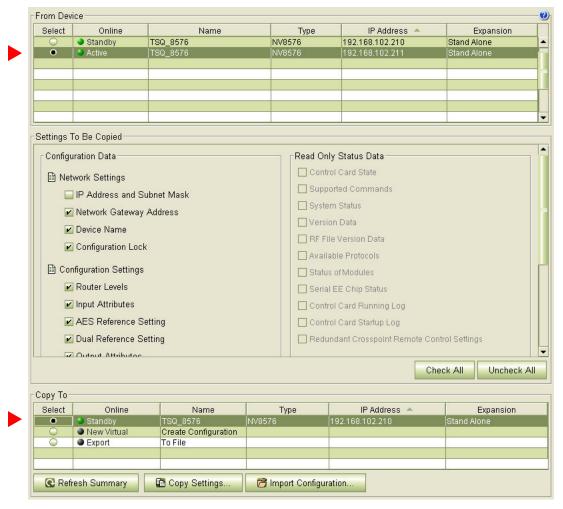
- 1 Go to the 'Copy Settings' page of MRC.
 - 2 Select **Card A** in the 'From Device' table at the top of the page. The 'To Device' table, at the bottom of the page, will redisplay according to your selection. Select **Card B** in the 'To Device' table.

- 3 Leave the entries in the 'Settings to Be Copied' section, in the middle of the page, at their defaults.
- 4 Click the 'Copy Settings' button.

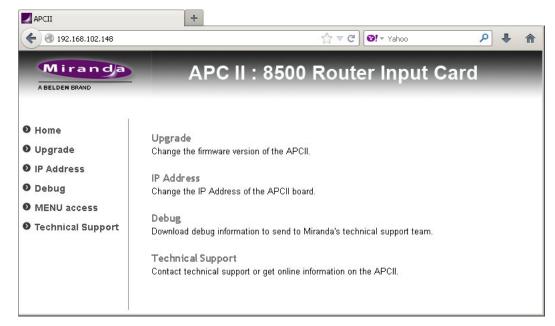
The application initially displays its main page or home page:

Note that the term "APC II" represents the frame sync input card.

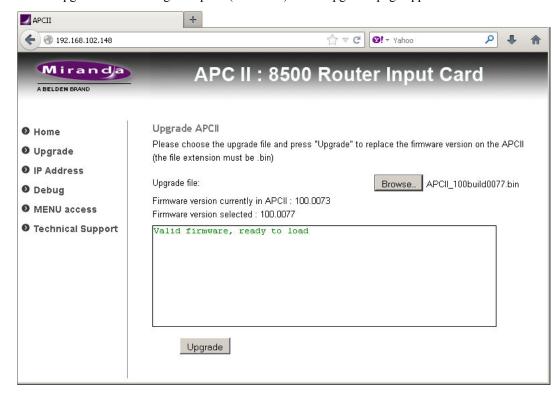
3 Click 'Upgrade' in the navigation pane (at the left). The 'Upgrade' page appears:

To update the frame sync software:

a Click the 'Browse' button. In the dialog that appears, navigate to select a .bin file for the card.

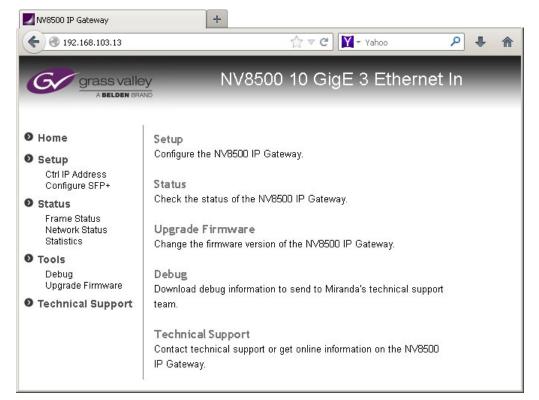
The application initially displays its main page or home page:

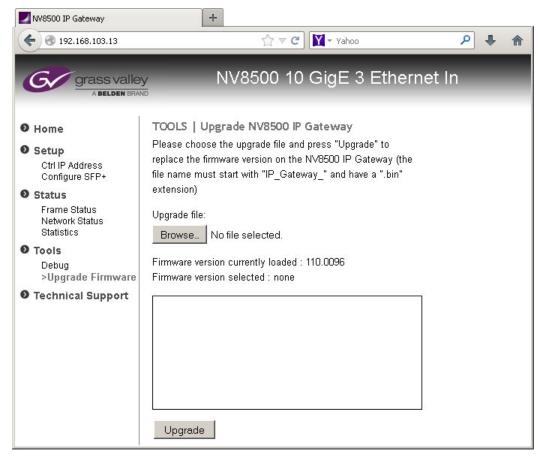
3 Click 'Upgrade Firmware' in the navigation pane (at the left). The upgrade page appears:

To update the IP gateway software:

a Click the 'Browse' button. In the dialog that appears, navigate to select a .bin file for the card.
